Supplemental Information & Instructions for Premium Ignition Rotors

151-805 or GRA2101HQ for 25D4 distributors (MGT, MGA, SPM 948-1275, TR2-4A)
151-865 or GRA2114HQ for 43B & 45D distributors (MGB 75-80, Midget/Spitfire 1500, XJ6 74-79)
872-785 or GRA102HQ for 25D6 distributors (Healey 100-6/3000, MGC, TR250, TR6 to 1974)

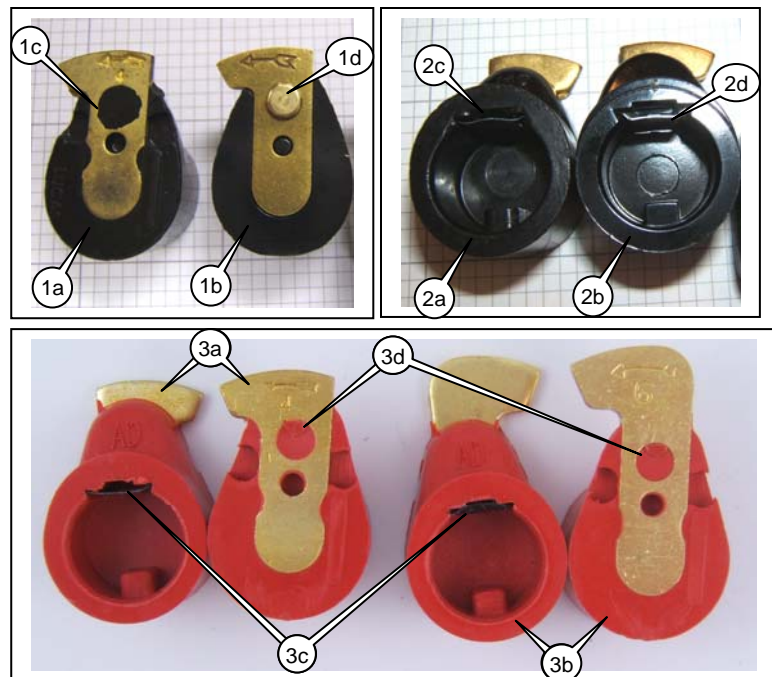
Rotor arms manufactured over the last decade are not exactly like the Lucas rotors (1a, 2a) made in the 50s and 60s. Specifically, these rotors (1b, 2b) have more carbon black in the plastic, which increases the conductivity of the material. On top of that, the original contact was molded into the body of the rotor (1c) while replacement rotors use a rivet. The lower end of the rivet is very close to the spring clip (2d) on the underside of the rotor. There is simply not a lot of insulating material separating the tip of the rivet and the spring clip. The high energy spark from the coil (30,000 volts or more) will always follow the path of least resistance. In some of these rotors, this path goes from the tip of the rivet, through the thin layer of more conductive plastic, through the spring clip on the underside of the rotor arm, finally grounding out on the shaft of the distributor. Initially when this happens one or more of the spark plugs will fail to fire.

This "miss" will sometimes heal itself if the engine is given a chance to cool off, but it always comes back, and in the end, the rotor will simply short out completely, which could leave you stuck on the side of the road.

The Premium Ignition Rotors we offer for Lucas distributors are based on the rotors made by Lucas in the 1960s for 4 and 6 cylinder applications. These rotors (3a, 3b) are manufactured from a highly non-conductive resin ideally suited for modern high-energy ignition systems. The brass contact is molded to the body when the body is made, eliminating the rivet. There is no chance for the contact to ground through to the distributor shaft. The socket is precisely sized, which, combined with the spring clip (3c), ensures that the rotor fits tightly on the distributor shaft. All of these factors combined make these Premium Rotors far superior to the other rotors available at this time, and this is reflected in the fact that they are warranted against defects in material and/or workmanship for three years.

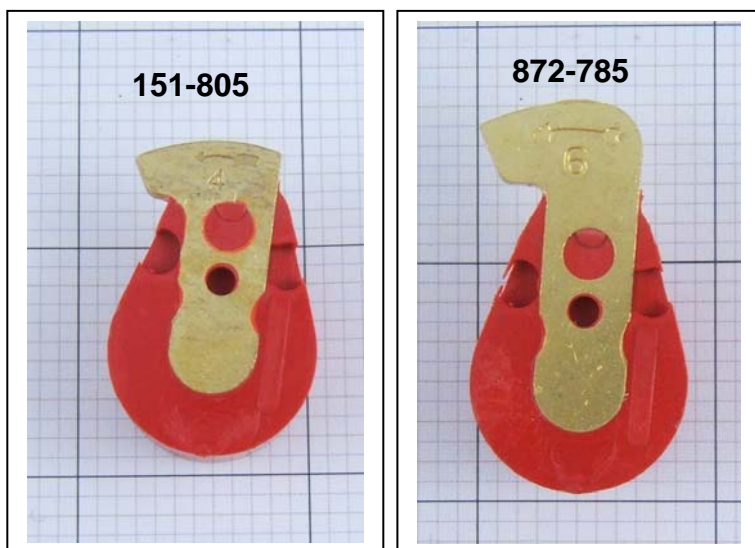
54 After years of use, the top of the distributor shaft may have been repeatedly cleaned with wire brushes or
55 emery cloth. Our supplier, who sees hundreds of used distributors every year, reports that it is quite
56 common to see distributor shafts with a smaller outside diameter. As a result, a new rotor at the upper
57 end of the original tolerance range may not fit snugly on the shaft. These Premium Rotors have a tighter
58 tolerance on the inside diameter with less variation between rotors, both of which help ensure a snug fit
59 on a used distributor shaft.
