1 Supplemental Information
2 for
3 **582-982 or ACB856 Brake & Clutch Fluid Reservoir**
4 **Austin Healey BN7 & BT7 1959 on, BJ7, BJ8**
5 **Triumph TR 3A TS41630 on, TR 3B**
6
7
8

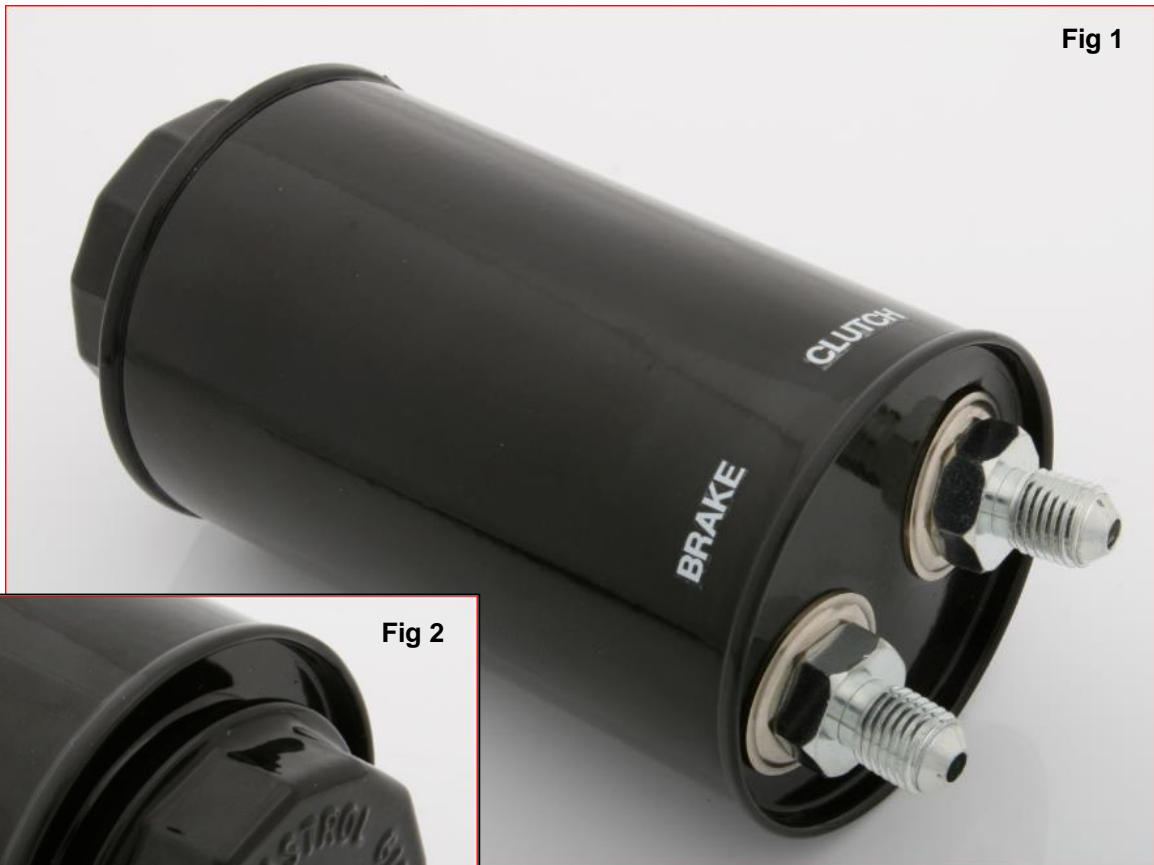
Fig 1

It has been so long since the original type Girling brake fluid reservoir has been available that the details have gotten a little fuzzy. Roger Moment provided photographs of a known good original and we were able to obtain samples of original reservoirs from Eric Grunden. The cap was a real challenge- so many have been mangled with various tools trying to get the rusted caps off that good examples were few and far between. We are happy to say that patience and perseverance have paid off. "USE ONLY CASTROL GIRLING FLUID" is stamped into the top.

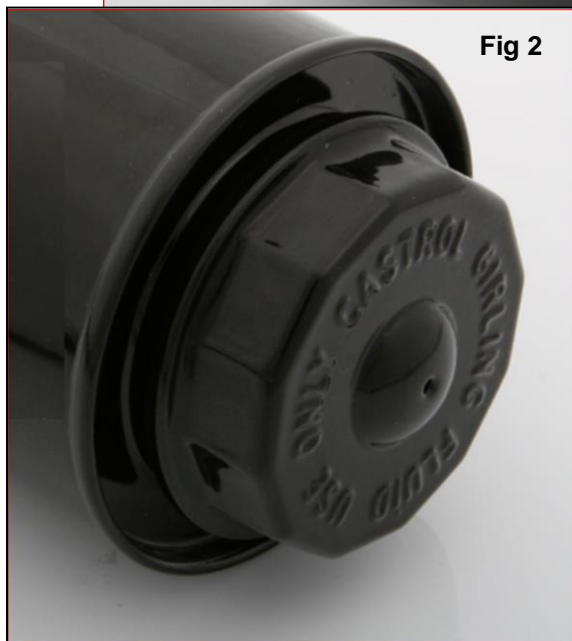
Fig 2

9
10
11
12
13
14
15
16
17
18
19
20
21
22
23
24
25
26
27
28
29
30
31
32
33
34
35
36
37
38
39
40
41
42
43
44
45
46
47
48
49 The can itself is plated, then the outside is painted black. This coating is highly resistant to brake fluid. In
50 our testing, brake fluid caused the paint to dull out, but it did not blister or lift. Unless you are using silicone
51 fluid, any brake fluid spill should be rinsed with water as quickly as possible to minimize the damage to the

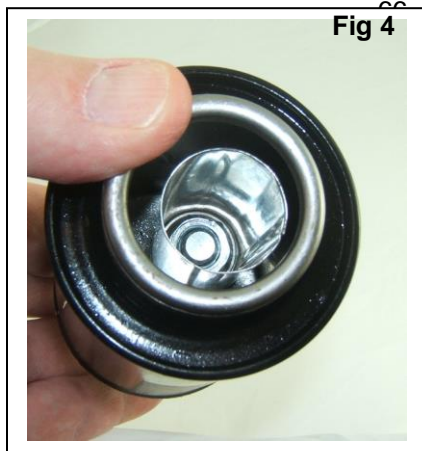
Fig 4

These special washers are also used to seal the clutch reservoir inside the main reservoir. The clutch reservoir tube is made from stainless steel, as are the new hex nuts that hold the whole assembly together.

By using stainless steel where it made sense we eliminated the possibility of rust forming on these components. The clutch reservoir tube is sized to allow a 1/4 inch drive socket on a long extension to be used to tighten/loosen the nut.

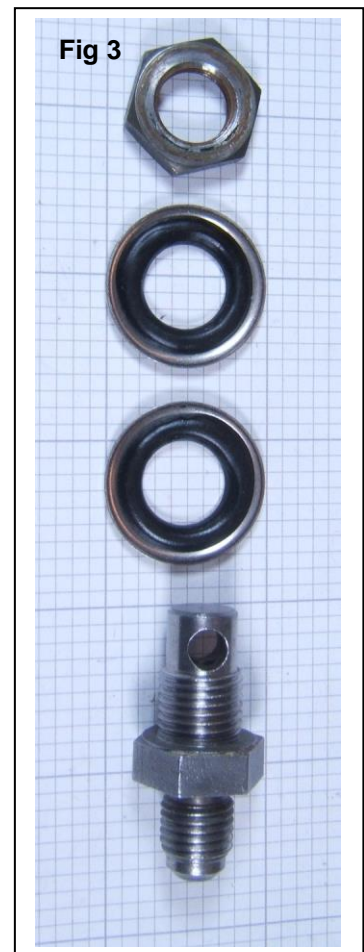
Fig 3

55 Our first change was made to eliminate the possibility of a leak around the
56 outlet fittings by replacing the copper washer on the outside and the original
57 sealing washer on the inside of the reservoir with special cupped stainless
58 steel washers that have an integral DuPont Viton o-ring. (Fig 3). When the nut
59 is tightened down, the Viton o-rings are compressed, forming a seal that is
60 impervious to all commercially available brake fluid. This is a significant
61 improvement over the copper washer, which tended to tear up the paint as
62 you tried to get enough "crush" to prevent a leak. Invisible to all but the most
63 thorough examination, this change is a significant improvement over the
64 original design. We also took the trouble to reproduce the original Girling
65 outlet fittings, which guarantees a good seal when new brake pipes are fitted.

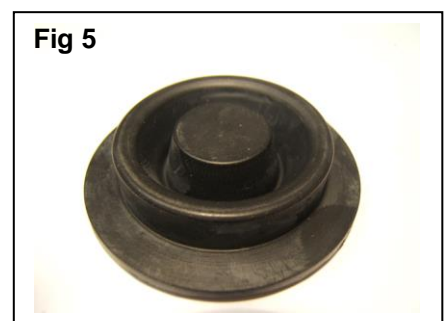
Fig 5

82 We also changed the cap sealing gasket from a simple flat ring of rubber to a
83 complete cover. (Fig 5). There are two reasons why. First, we were aware of
84 an annoying tendency for brake fluid to squirt up out through the vent in the
85 cap. This is especially true of the Girling caps (and replacements) which
86 have the two vent holes in line with each other. We off-set the vent hole on
87 the inside with this in mind, but the "anti-splash" seal makes it impossible for
88 fluid to escape. The second reason for using this type of seal is to limit the
89 amount of atmospheric moisture that can get to the brake fluid. There is a
90 tiny slit in the seal that will allow air pressure to equalize as needed, but the
91 seal greatly reduces the exposure of brake fluid to moisture. This will
92 effectively increase the life of conventional brake fluid, and help reduce the
93 damage water can do. (For more information on this topic, see our website
